Flood Damage Reduction Segment / System Inspection Report

Name of Segment / System: Luna Pier Advanced Measures Flood Damage Reduction Project

Public Sponsor(s): City of Luna Pier

Type of Inspection:	<input type="checkbox"/> Initial Eligibility Inspection <input checked="" type="checkbox"/> Continuing Eligibility Inspection (Routine) <input type="checkbox"/> Continuing Eligibility Inspection (Periodic)	Overall Segment / System Rating:	<input type="checkbox"/> Acceptable <input type="checkbox"/> Minimally Acceptable <input checked="" type="checkbox"/> Unacceptable
Contents of Report:	<input checked="" type="checkbox"/> Instructions <input type="checkbox"/> Initial Eligibility Inspection <input checked="" type="checkbox"/> General Items for All Flood Control Works <input checked="" type="checkbox"/> Levee Embankment <input checked="" type="checkbox"/> Concrete Floodwalls <input type="checkbox"/> Sheet Pile and Concrete I-walls <input type="checkbox"/> Interior Drainage System <input type="checkbox"/> Pump Stations <input type="checkbox"/> FDR System Channels	<p>Note: In addition to the report contents indicated here, a plan view drawing of the system, with stationing, should be in

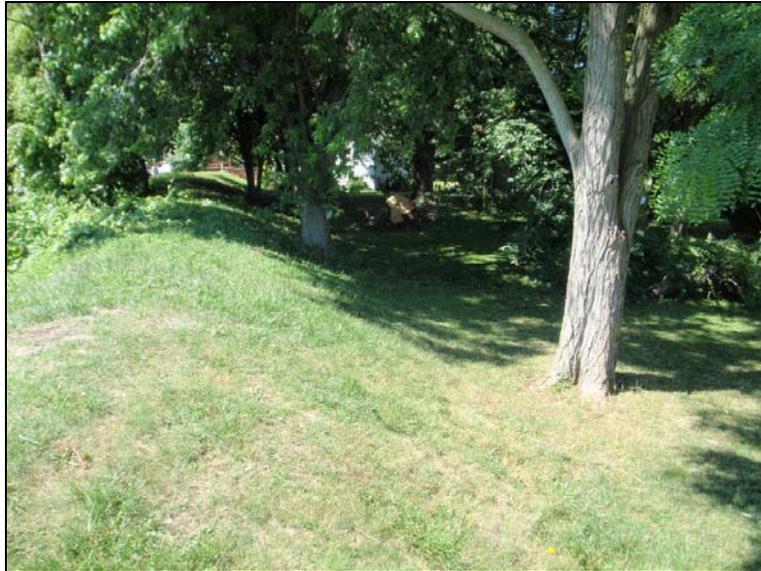
Inspect ID: lp01_2011_a_0028 **Title:** USACE_CELRE_lp01_2011_a_0028_1.jpg
Rated Item: 1. Unwanted Vegetation Growth **Caption:** Large tree on land side of protection.

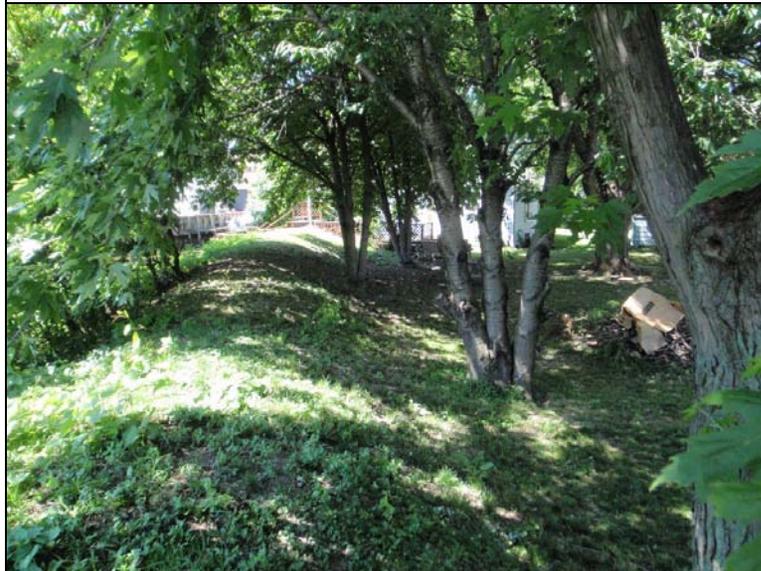
Inspect ID: lp01_2011_a_0029 **Title:** USACE_CELRE_lp01_2011_a_0029_1.jpg
Rated Item: 1. Unwanted Vegetation Growth **Caption:** Large tree on land side of protection.

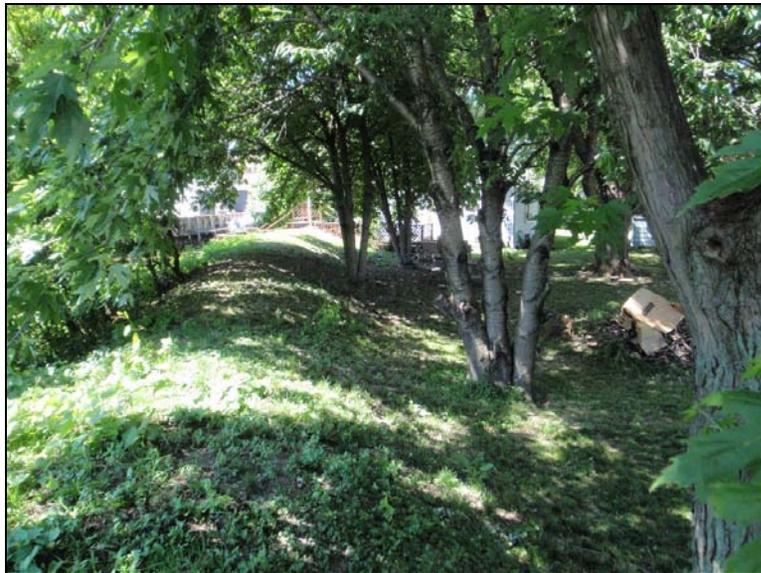
Inspect ID: lp01_2011_a_0031 **Title:** USACE_CELRE_lp01_2011_a_0031_1.jpg
Rated Item: 1. Unwanted Vegetation Growth **Caption:** Area of heavy vegetation on levee.

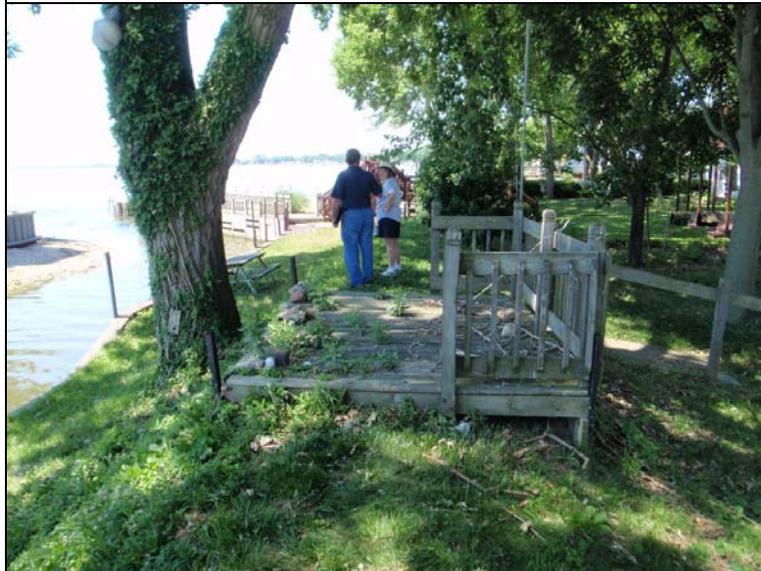
Inspect ID: lp01_2011_a_0067 **Title:** USACE_CELRE_lp01_2011_a_0067_1.jpg
Rated Item: 1. Unwanted Vegetation Growth **Caption:** Large cottonwood tree

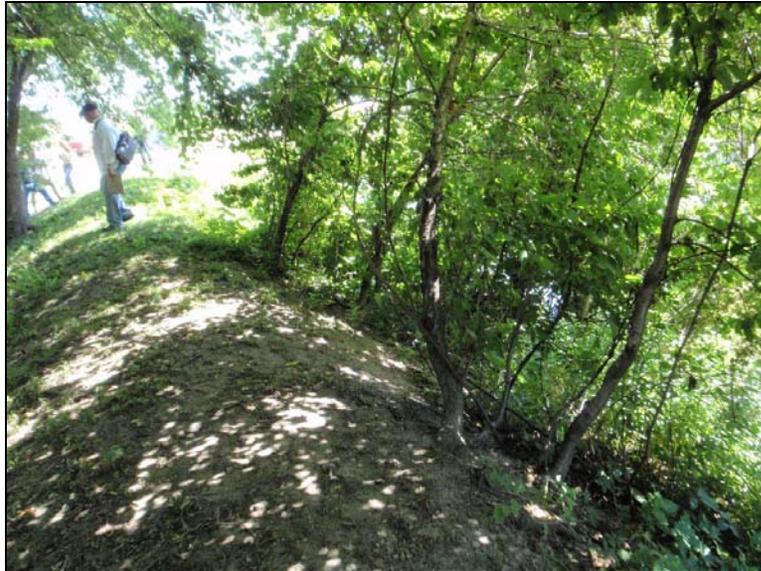
lp01_2011_a_0035: area of no sod cover: NA (M) lp01_2011_a_0068: area of no sod cover: NA (M)

Inspect ID: lp01_2011_a_0035 **Title:** USACE_CELRE_lp01_2011_a_0035_1.jpg
Rated Item: 2. Sod Cover **Caption:** No grass cover due to shading from vegetation. Area more prone to erosion during overtopping.

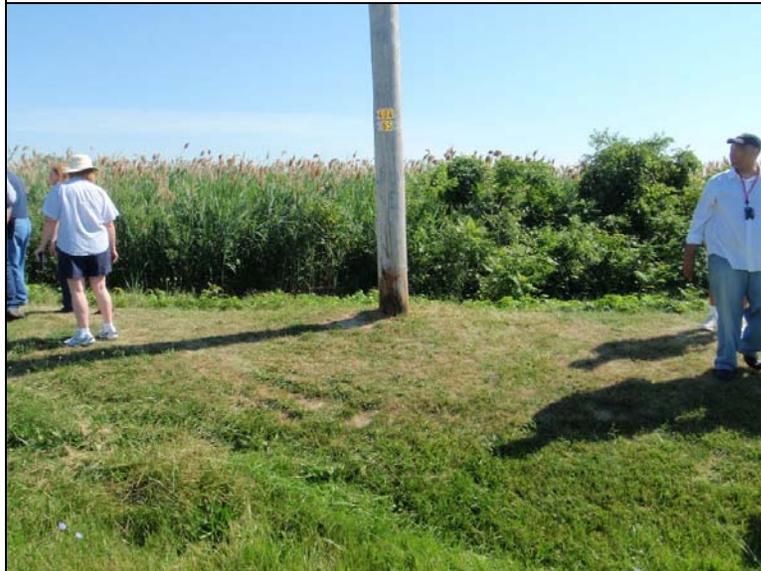
Inspect ID: lp01_2011_a_0001 **Title:** USACE_CELRE_lp01_2011_a_0001_1 **Rated Item:** 3. Encroachments **Caption:** Telephone encroachment in levee

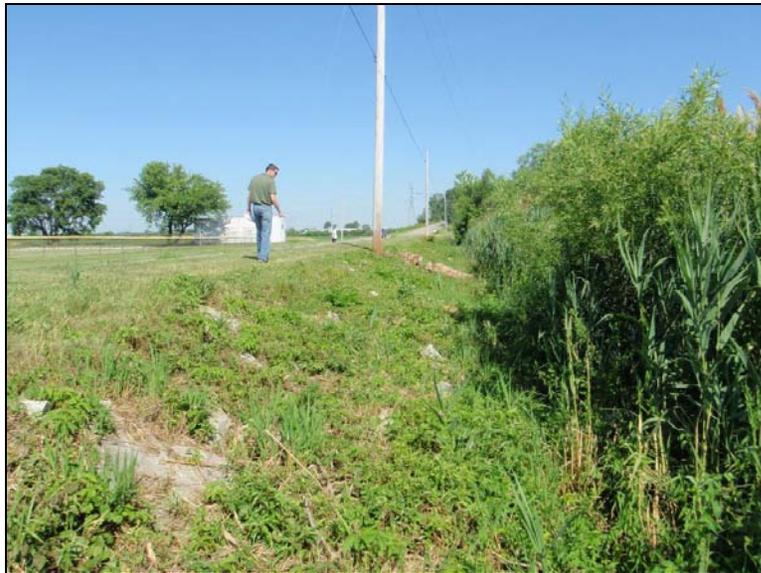
Inspect ID: lp01_2011_a_0003 **Title:** USACE_CELRE_lp01_2011_a_0003_1.jpg
Rated Item: 3. Encroachments **Caption:** Telephone encroachment

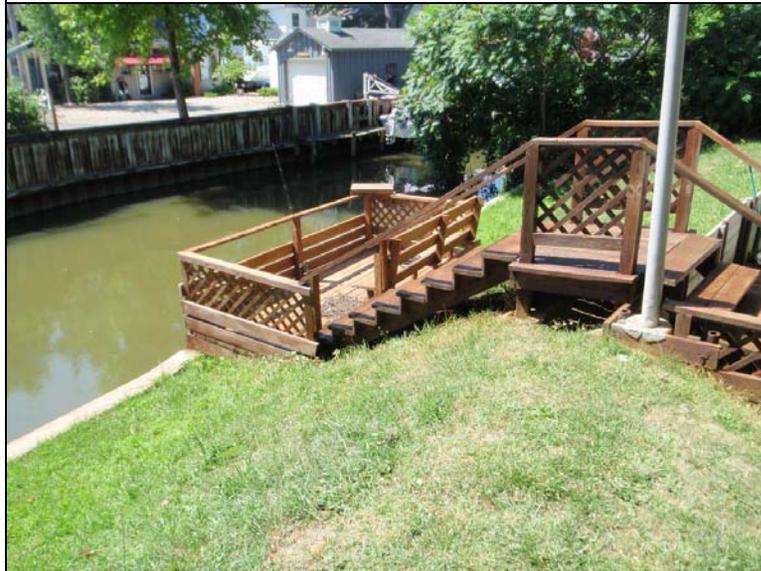
Inspect ID: lp01_2011_a_0036 **Title:** USACE_CELRE_lp01_2011_a_0036_1.jpg
Rated Item: 3. Encroachments **Caption:** Deck built into levee

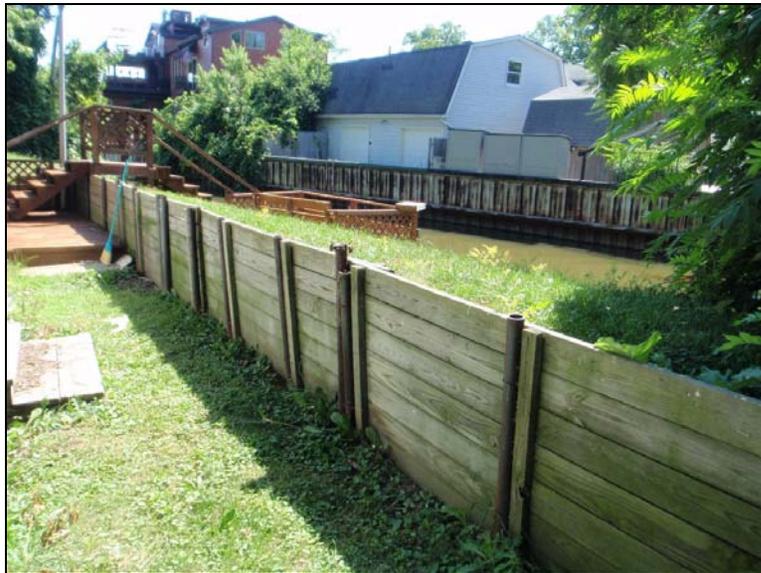
Inspect ID: lp01_2011_a_0037 **Title:** USACE_CELRE_lp01_2011_a_0037_1.jpg
Rated Item: 3. Encroachments **Caption:** Retaining wall constructed on land side of levee; toe removed.

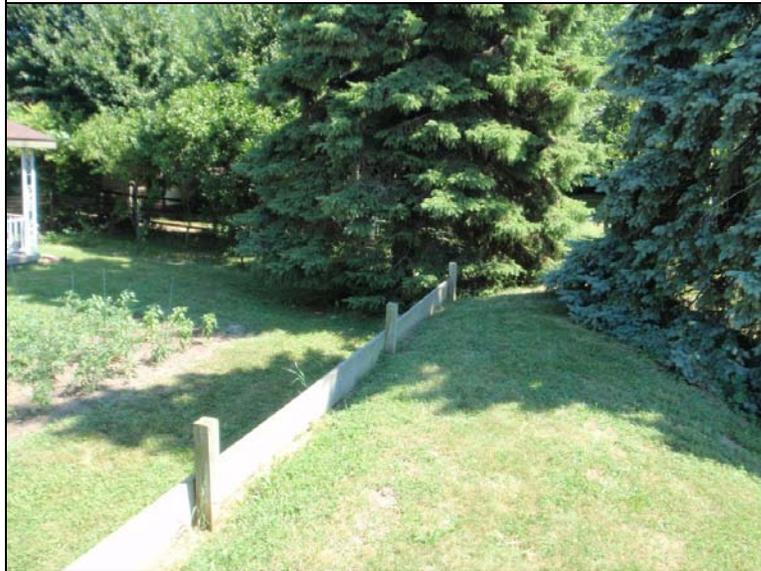
Inspect ID: lp01_2011_a_0042 **Title:** USACE_CELRE_lp01_2011_a_0042_1.jpg
Rated Item: 3. Encroachments **Caption:** Wood retaining wall constructed into the land side of the levee. Toe removed.

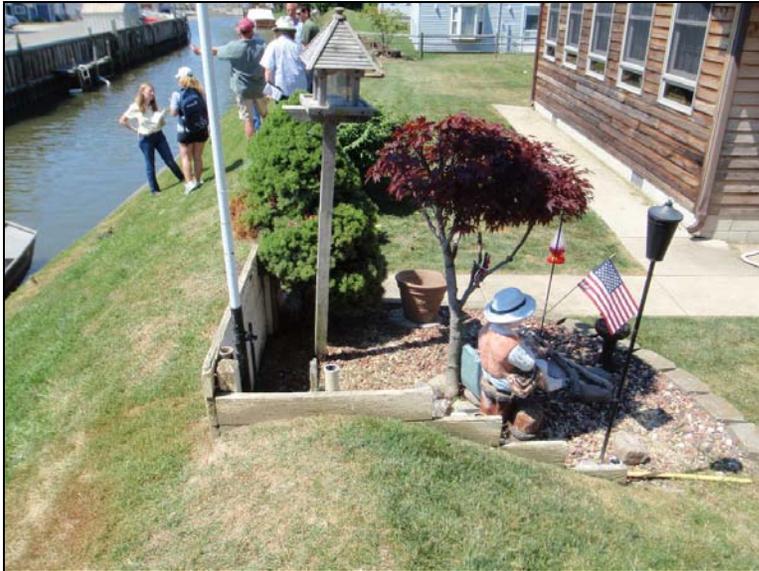
Inspect ID: lp01_2011_a_0049 **Title:** USACE_CELRE_lp01_2011_a_0049_1.jpg
Rated Item: 3. Encroachments **Caption:** Wood retaining wall built into land side of levee. Toe removed.

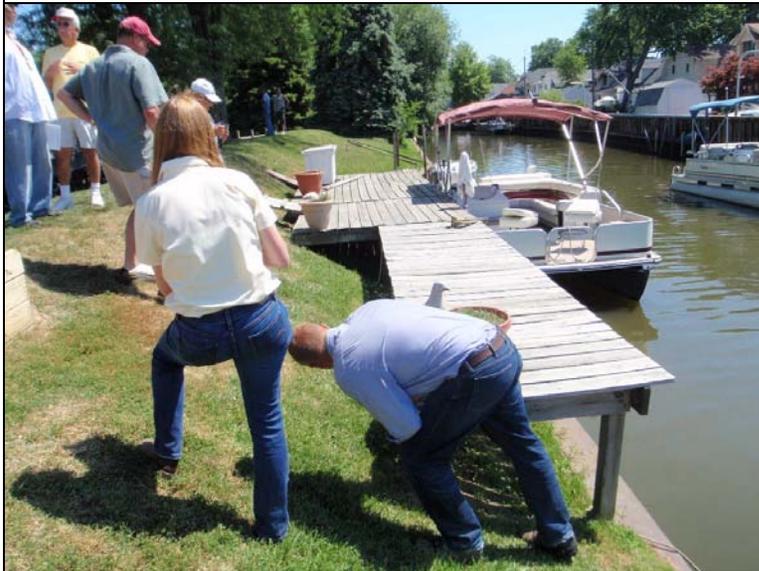
Inspect ID: lp01_2011_a_0055 **Title:** USACE_CELRE_lp01_2011_a_0055_1.jpg
Rated Item: 3. Encroachments **Caption:** Wood boat dock

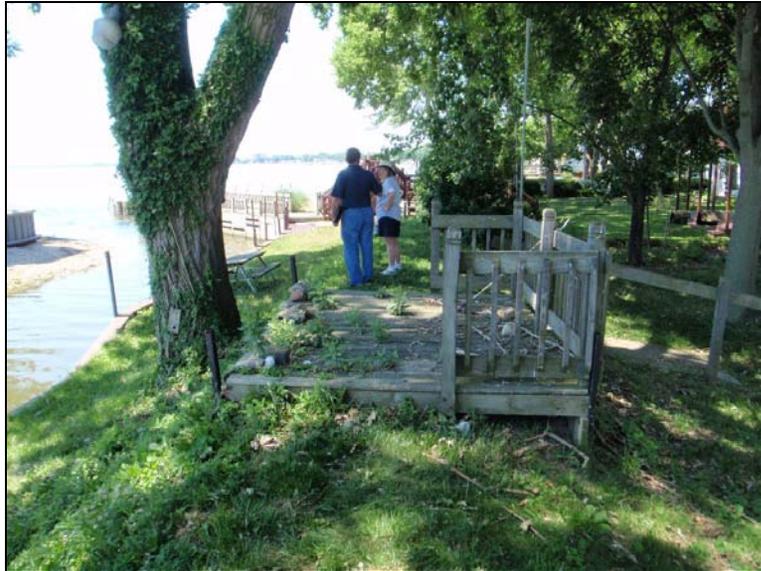
Rated Item	Rating	Rating Guidelines	Location/Remarks/Recommendations
			lp01_2011_a_0059: Sand bags at toe of levee. Placed without USACE approval (M) lp01_2011_a_0062: jetski ramp constructed on levee, slope is very steep (U) lp01_2011_a_0065: flag pole foundation (M) lp01_2011_a_0066: wood deck constructed on levee (U)

Inspect ID: lp01_2011_a_0066 **Title:** USACE_CELRE_lp01_2011_a_0066_1.jpg
Rated Item: 3. Encroachments **Caption:** Wood deck

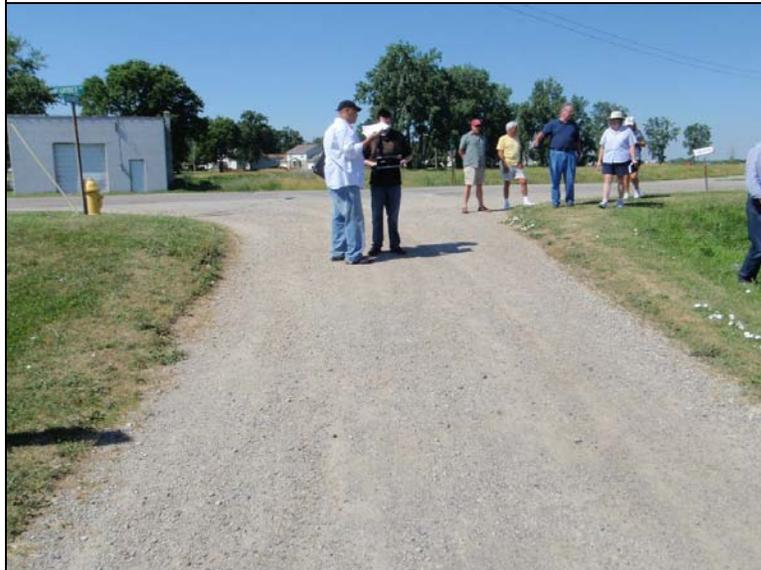
Inspect ID: lp01_2011_a_0020 **Title:** USACE_CELRE_lp01_2011_a_0020_1 **Rated Item:** 4. Closure Structures (Stop Log, Earthen Closures, Gates, or Sandbag Closures) (A or U only) **Caption:** Low area in levee protection at road crossing.

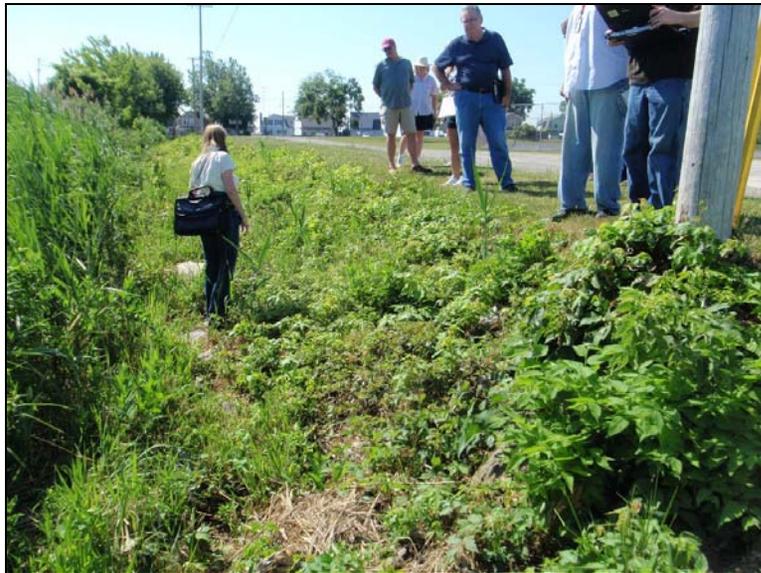
Inspect ID: lp01_2011_a_0002 **Title:** USACE_CELRE_lp01_2011_a_0002_1.jpg
Rated Item: 5. Slope Stability **Caption:** Erosion along levee slope.

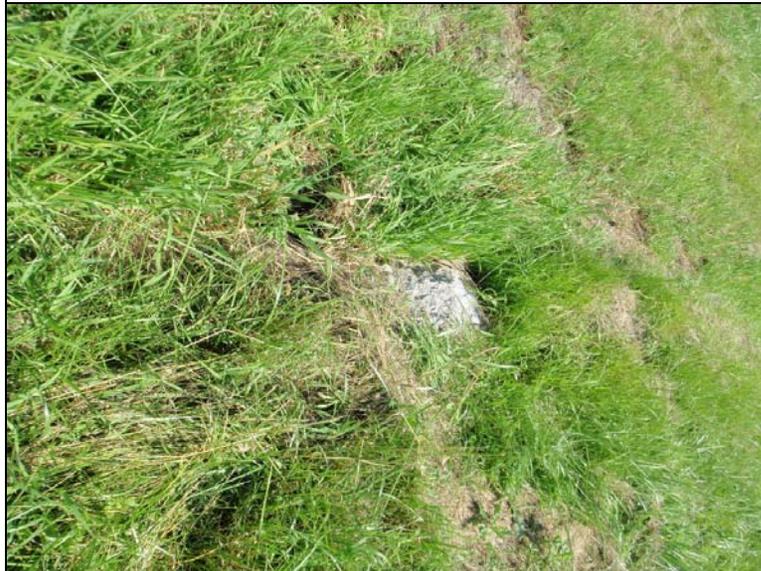
7. Settlement ²	M	A	No observed depressions in crown. Records exist and indicate no unexplained historical changes.
		M	Minor irregularities that do not threaten integrity of levee. Records are incomplete or inclusive.
		U	Obvious variations in elevation over significant reaches. No records exist or records indicate that design elevation is compromised.
			lp01_2011_a_0020: Station_1 NA: Low point in level of protection at road crossing.: Emergency action plan should identify area for sand bagging during floods. (A) lp01_2011_a_0002: Station_1 NA: Lakeside slope of levee has shallow failure. Does not intersect the crest of the levee.: Levee slopes need to be repaired and maintained, to include mowing. (M) lp01_2011_a_0013: Station_1 NA: End of shallow slope failures.: NA (M) lp01_2011_a_0025: Station_1 NA: bank erosion noted on river side of levee.: Repair slope and reseed. (M) lp01_2011_a_0021: Station_1 NA: Settlement from drainage pipe that has been removed.: Recommend filling low area. (M)

Inspect ID: lp01_2011_a_0021 **Title:** USACE_CELRE_lp01_2011_a_0021_1.jpg
Rated Item: 7. Settlement **Caption:** Areas of settlement in area where pipe was removed.

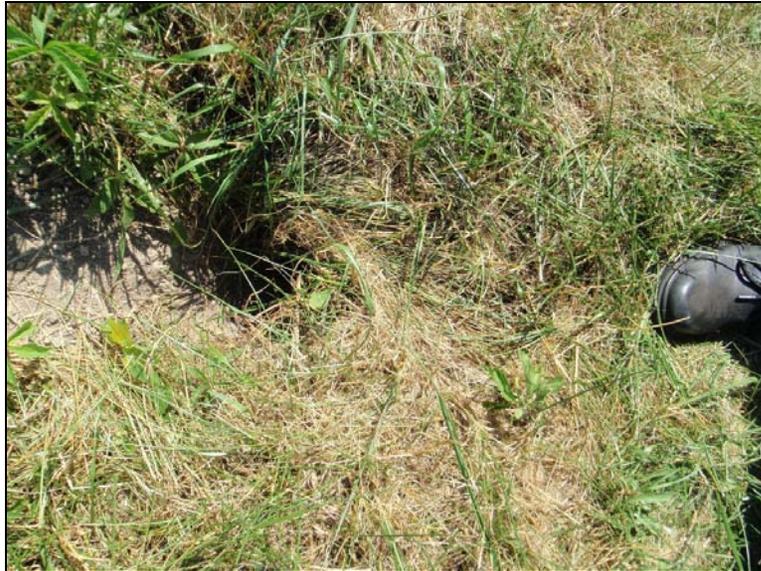
10. Animal Control	M	A	Continuous animal burrow control program in place that includes the elimination of active burrowing and the filling in of existing burrows.	lp01_2011_a_0006: Station_1 NA: animal burrow noted: Fill hole (M) lp01_2011_a_0011: Station_1 NA: animal burrow: fill hole and reseed (M) lp01_2011_a_0050: Station_1 NA: small animal burrow in levee: NA (M) lp01_2011_a_0057: Station_1 NA: rodent hole in levee needs to be filled: NA (M) lp01_2011_a_0094: Station_1 NA: large rodent hole: NA (M)
		M	The existing animal burrow control program needs to be improved. Several burrows are present which may lead to seepage or slope stability problems, and they require immediate attention.	
		U	Animal burrow control program is not effective or is nonexistent. Significant maintenance is required to fill existing burrows, and the levee will not provide reliable flood protection until this maintenance is complete.

Inspect ID: lp01_2011_a_0006 **Title:** USACE_CELRE_lp01_2011_a_0006_1.jpg
Rated Item: 10. Animal Control **Caption:** Animal burrow in levee

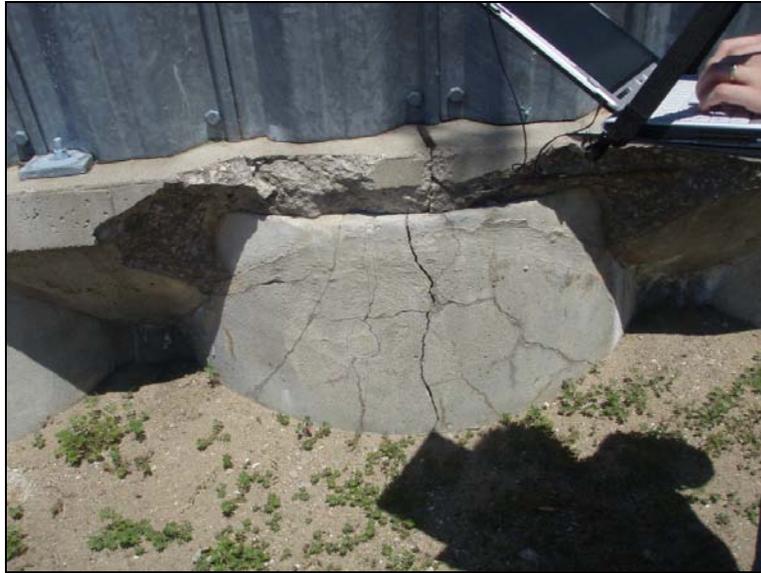
4. Concrete Surfaces	U	A	Negligible spalling, scaling or cracking. If the concrete surface is weathered or holds moisture, it is still satisfactory but should be seal coated to prevent freeze/ thaw damage.	lp01_2011_a_0070: repaint wave deflector, clean and paint to protect from corrosion.(M) lp01_2011_a_0072: Cracking observed at center line of cells, at control joints (M) lp01_2011_a_0073: Concrete cracking and spalling. Exposed rebar: Repair concrete spalls and seal cracks. (U)
		M	Spalling, scaling, and open cracking present, but the immediate integrity or performance of the structure is not threatened. Reinforcing steel may be exposed. Repairs/ sealing is necessary to prevent additional damage during periods of thawing and freezing.

Inspect ID: lp01_2011_a_0072 **Title:** USACE_CELRE_lp01_2011_a_0072_1.jpg
Rated Item: 4. Concrete Surfaces **Caption:** Deterioration of concrete cells

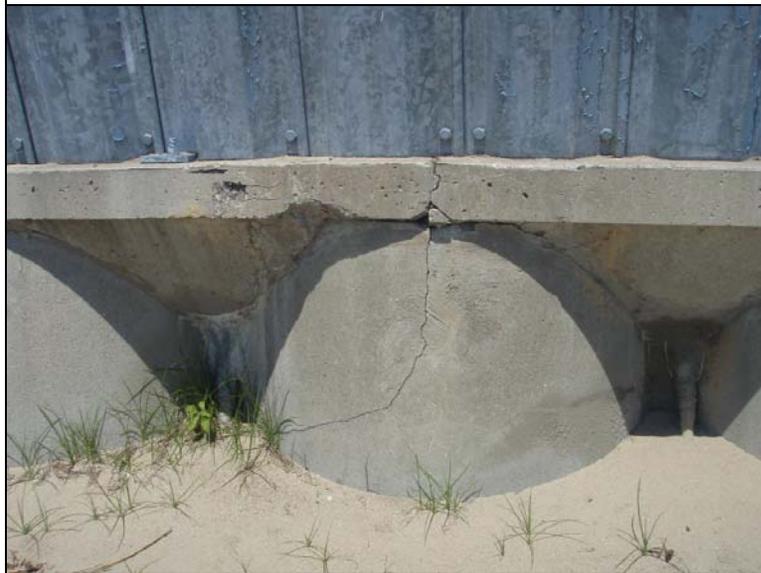
Inspect ID: lp01_2011_a_0074 **Title:** USACE_CELRE_lp01_2011_a_0074_1.jpg
Rated Item: 6. Foundation of Concrete Structures **Caption:**

6. Foundation of	U	<p>A No active erosion, scouring, or bank caving that might endanger the structure's stability.</p>	lp01_2011_a_0074: exposed screw anchor: Replace riprap
